MISCELLANEOUS PAPER SL-80-13

INVESTIGATION OF DISTRESSED
COMPOSITE WALLS, U. S. ARMY RESERVE
ARMORY, GREENWOOD, MISSISSIPPI

September 1980

Report to U. S. Army Engineer District, Ft. Worth
Ft. Worth, Texas 76102

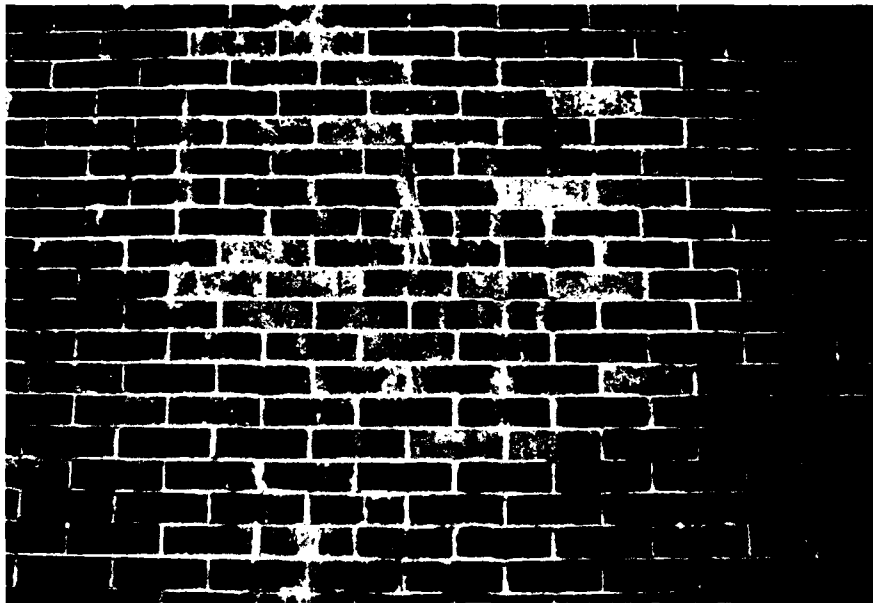
2. Examination of the exterior of the building revealed evidence of efflorescence (Figure 2), open mortar joints, and epoxy grout mortar joint repair at certain locations. The exterior examination was interrupted by an afternoon rain shower. When the investigation was resumed the following day, it was discovered that certain CMU surfaces of the roof parapet displayed evidence of a moisture content gradient as shown by surface discoloration and shading (Figure 3).

Figure 2. Typical efflorescence on exterior wall

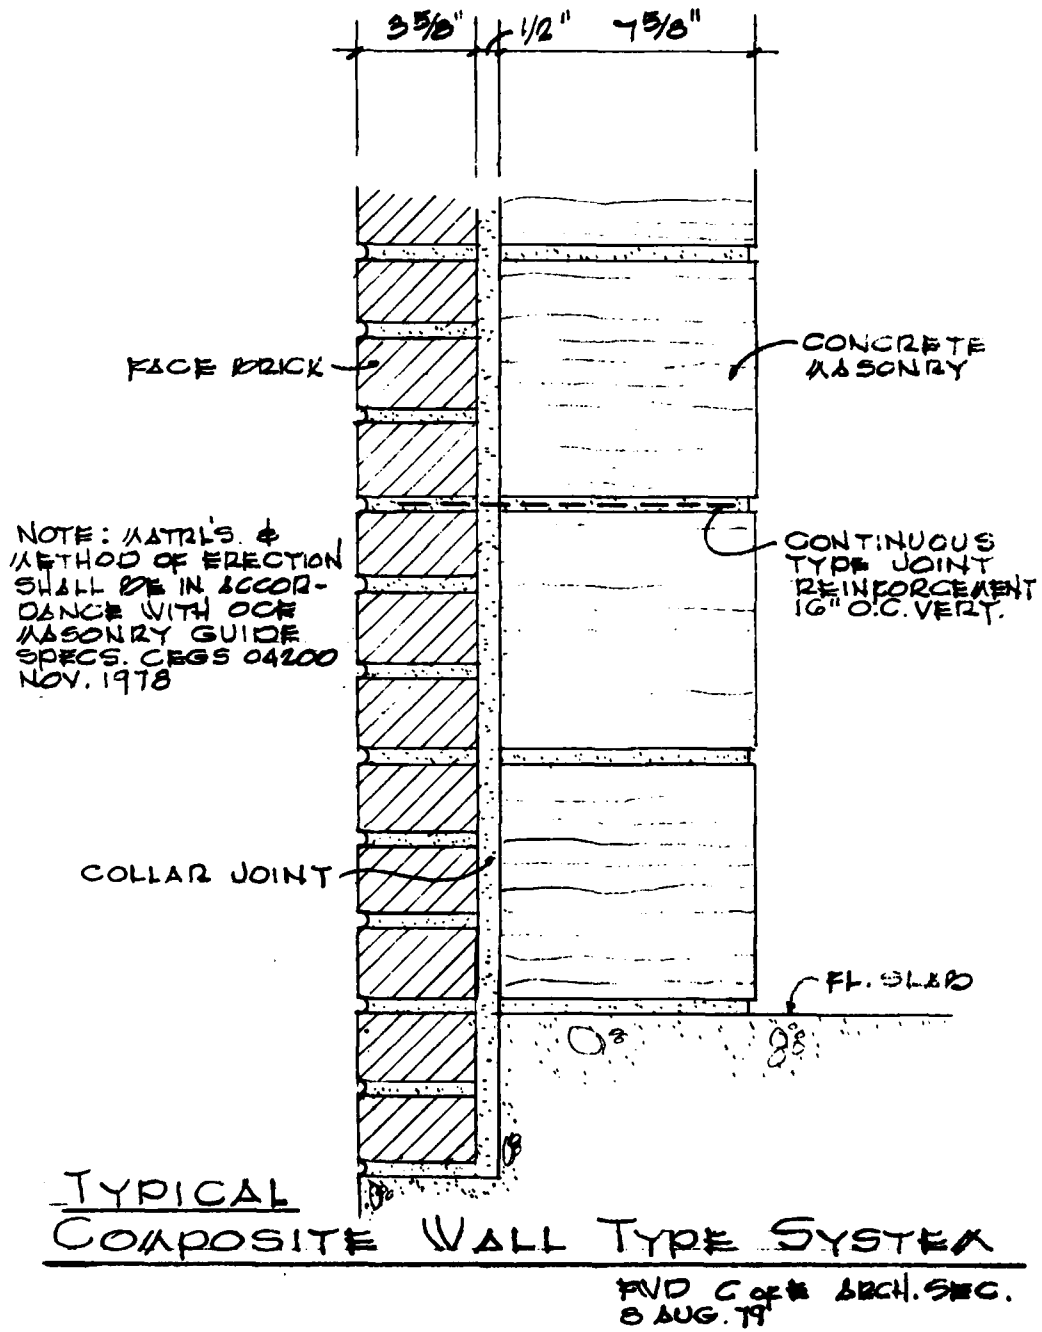
Figure 4

12. Two composite wall models were constructed in accordance with Figure 4. The pedestal was 4 ft long with the model wall being four brick courses high on the exterior face and one block high on the interior (Figure 5). A collection trough was formed in the pedestal at the outer edge of the base of the blocks and was used to collect any water migrating through the bricks for measurement. One model was used for a spray test and the other for static head test.

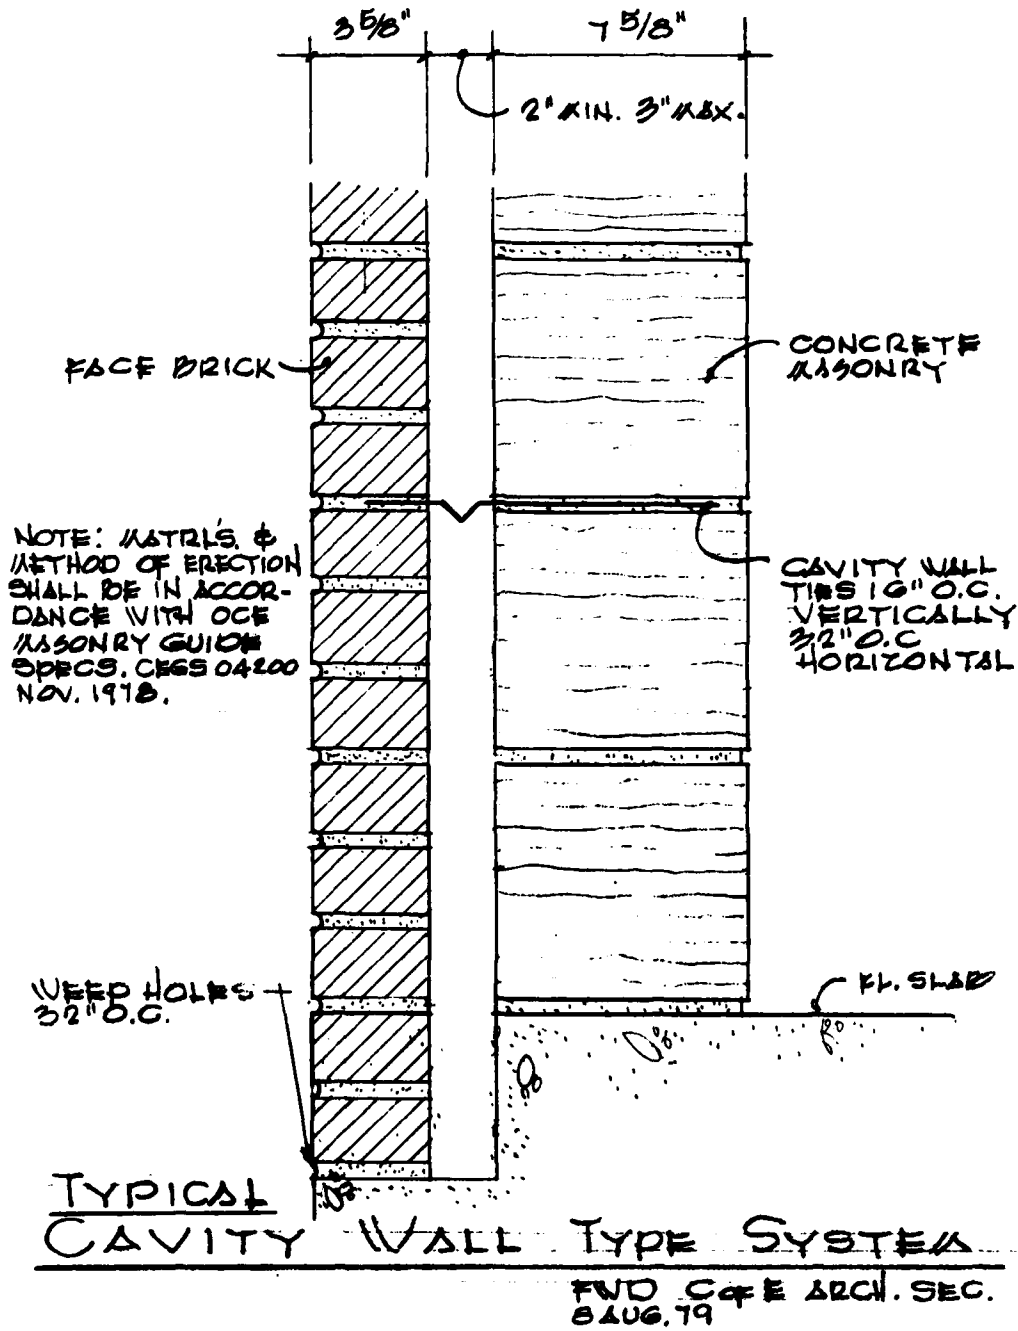
Figure 6

13. Two cavity wall models were constructed in accordance with Figure 6. The pedestals were 4 ft long with the model wall being four brick courses high on the exterior face and one block high on the interior (Figure 7). One model was used for the spray test and the other for the static head test.
